LAKE KALMIA DAM

NJ 00166

PHASE 1 INSPECTION REPORT
NATIONAL DAM SAFETY PROGRAM

AUGUST 1981

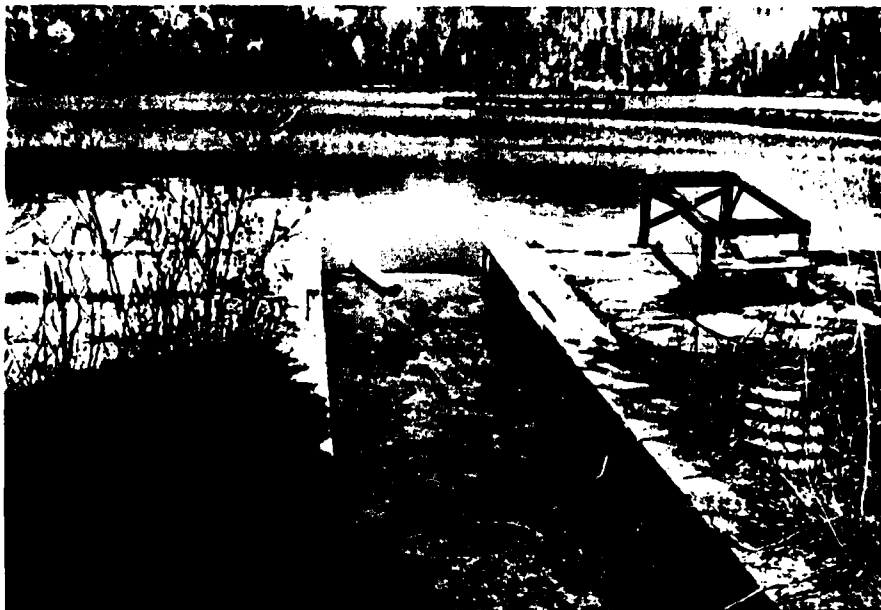
A depression was observed in the crest of dam near the upstream face adjacent to the left side of the spillway flume. The concrete slab covering the crest is cracked and settled in this area.

The depression and cracking of the concrete slab on the dam crest near the upstream face and left side of the spillway flume may be indicative of internal erosion and should be corrected.

Dam crest, note settlement and cracking of concrete adjacent to iron diving platform.

- (1) Investigate the cause of the depression and cracking of the concrete slab on the dam crest and design and oversee required corrective measures.
- (2) Design and oversee procedures for the removal of trees and their root systems from the crest and downstream slope of the dam.
- (3) Evaluate the potential for erosion and undermining of the downstream toe of the dam caused by the flow of water from seepage near the right abutment.
- (4) Investigate the cause of seepage and wet, soft areas along the downstream toe of the spillway and design remedial measures.

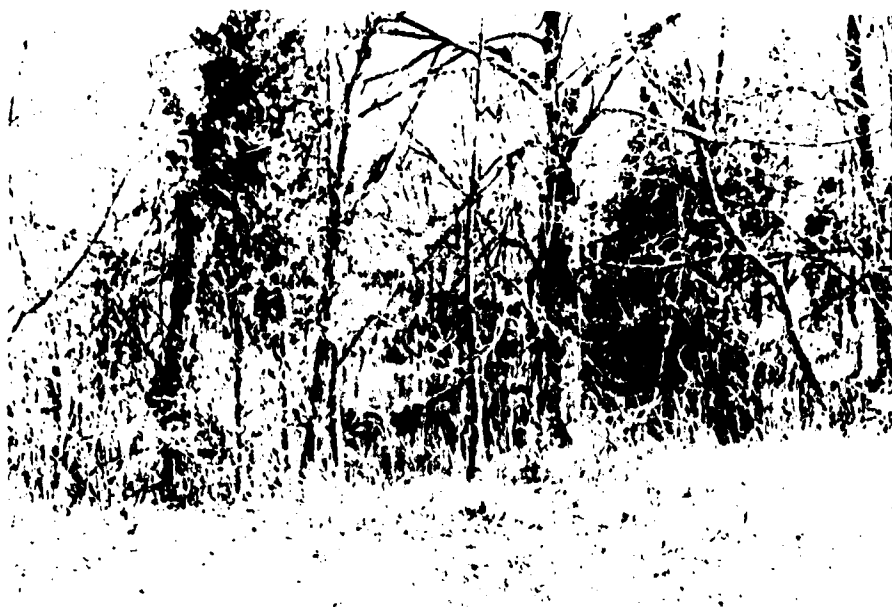
Under test flood conditions the natural saddle 400 feet east of the dam, which might serve as an emergency spillway would convey 96 cfs, with 26 cfs going over the spillway and 372 cfs over the dam crest. The elevation of the natural saddle is higher than the dam crest, so it does not increase project capacity at the top of the dam.

Saddle about 400 feet east of dam that probably would serve as emergency spillway. Looking at upstream face from west side of bay.
